**CORROSION CONDITION SURVEY  
OF U1020 MONTANA AVENUE OVERPASS-BILLINGS  
FOR  
MONTANA DEPARTMENT OF TRANSPORTATION  
WJE No. 2000.2547  
November 27, 2000**

CORROSION CONDITION SURVEY  
OF U1020 MONTANA AVENUE OVERPASS-BILLINGS  
FOR  
MONTANA DEPARTMENT OF TRANSPORTATION  
WJE No. 2000.2547  
November 27, 2000

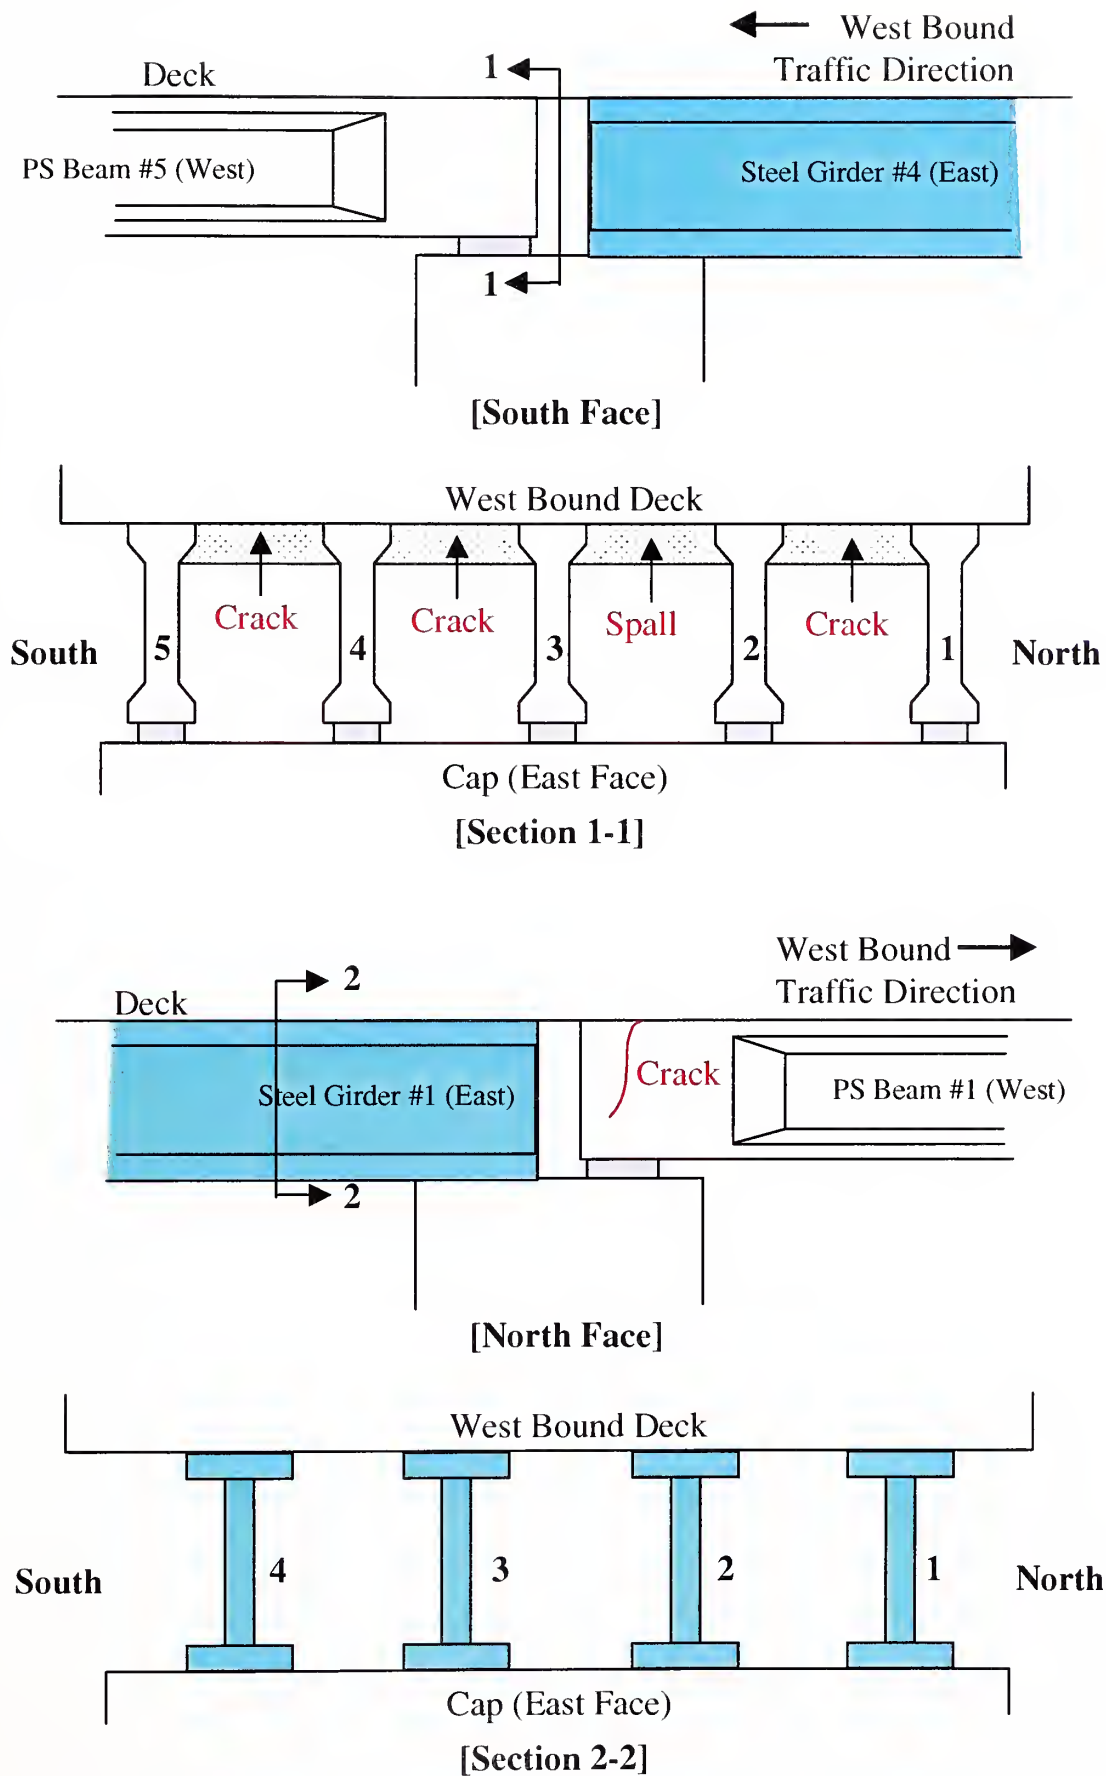
Figure 38B. Condition of Beam Joints over Bent No. 8 (West Bound).

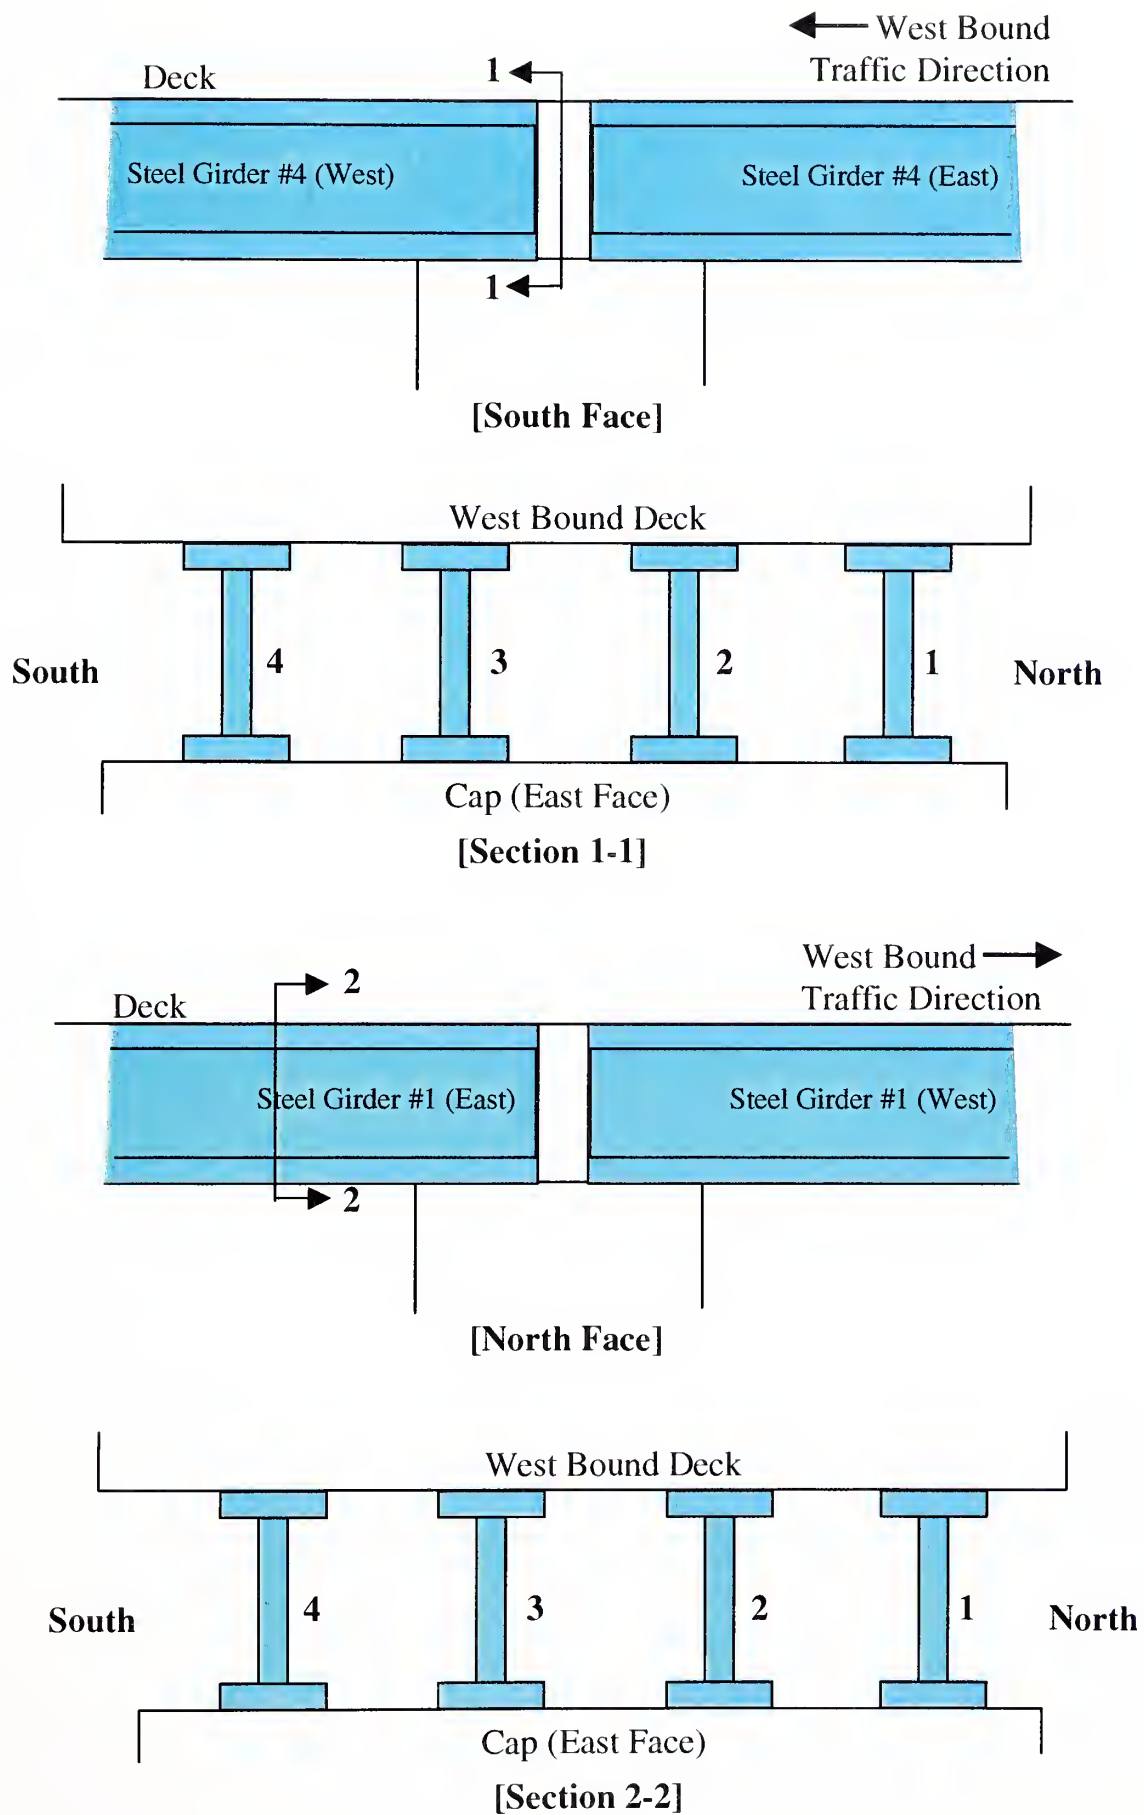
**Figure 39B. Condition of Girder Joints over Bent No. 9 (West Bound).**

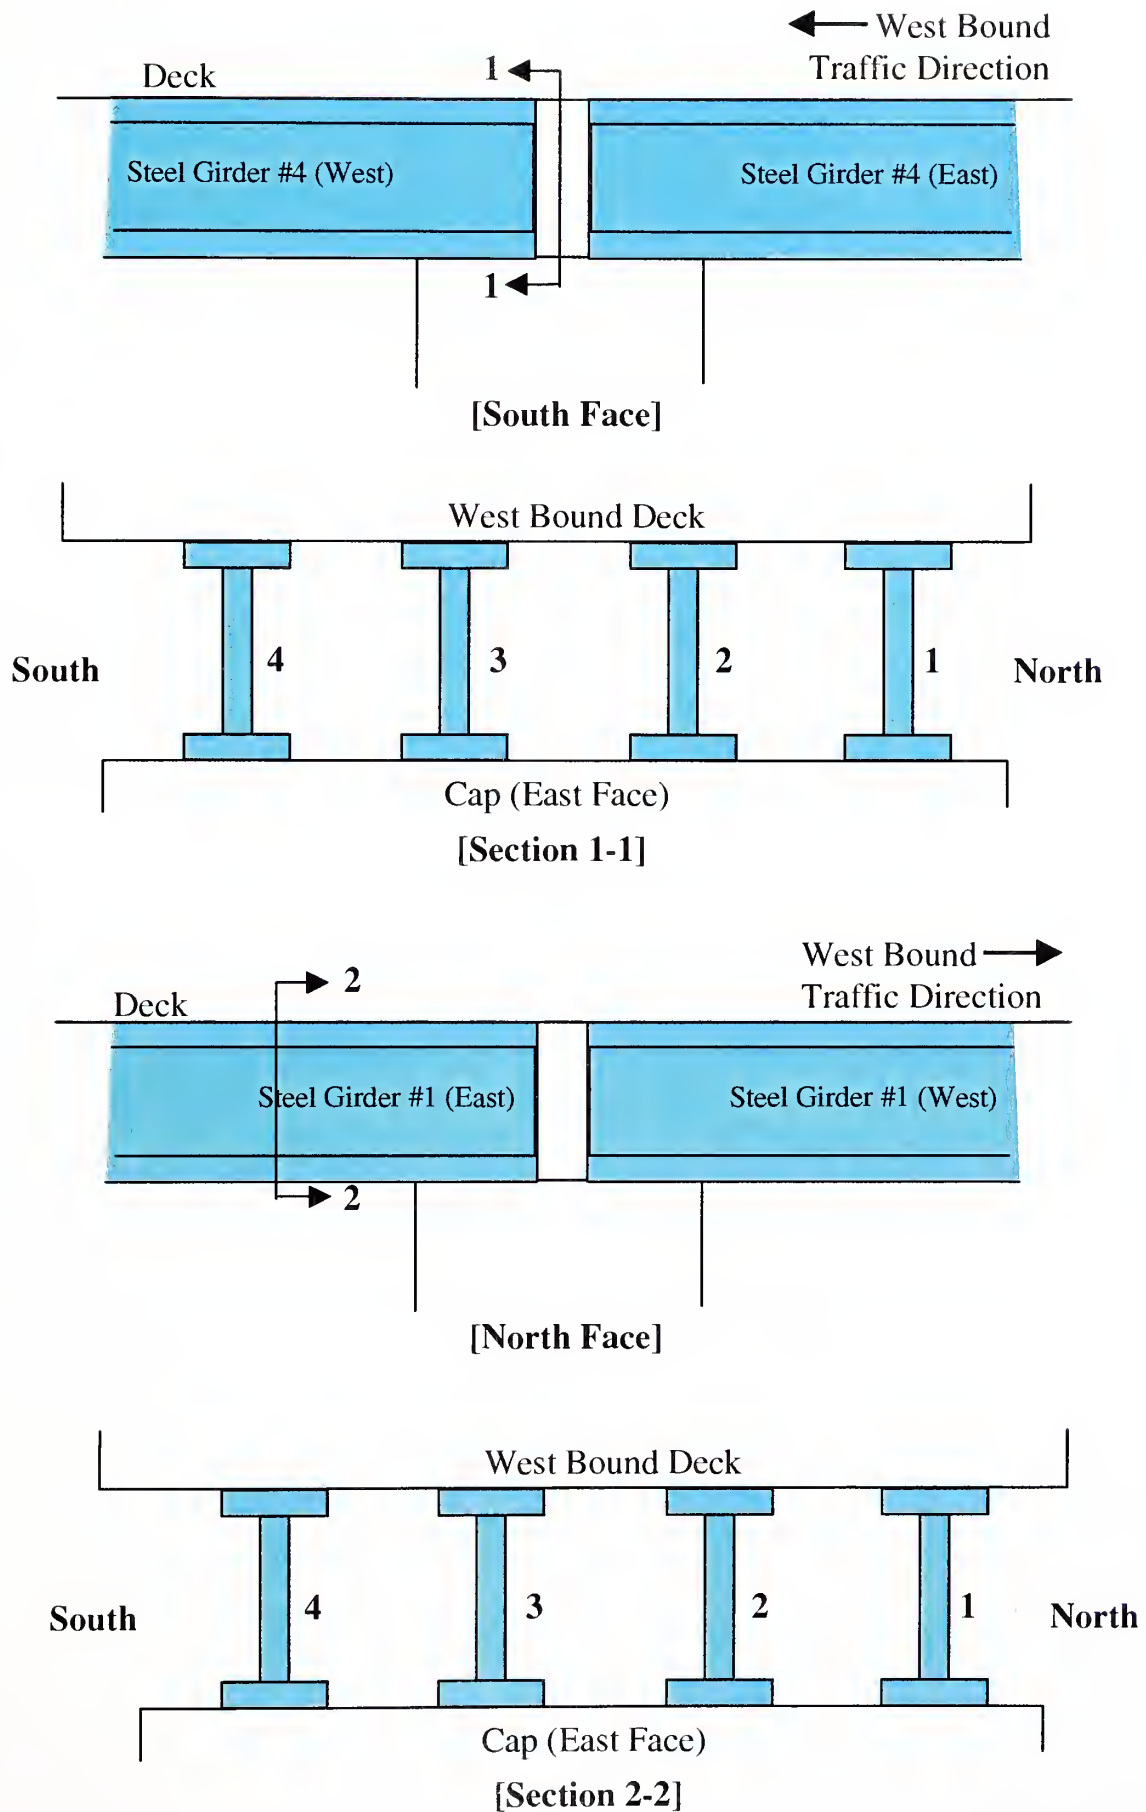
Figure 40B. Condition of Girder Joints over Bent No. 10 (West Bound).

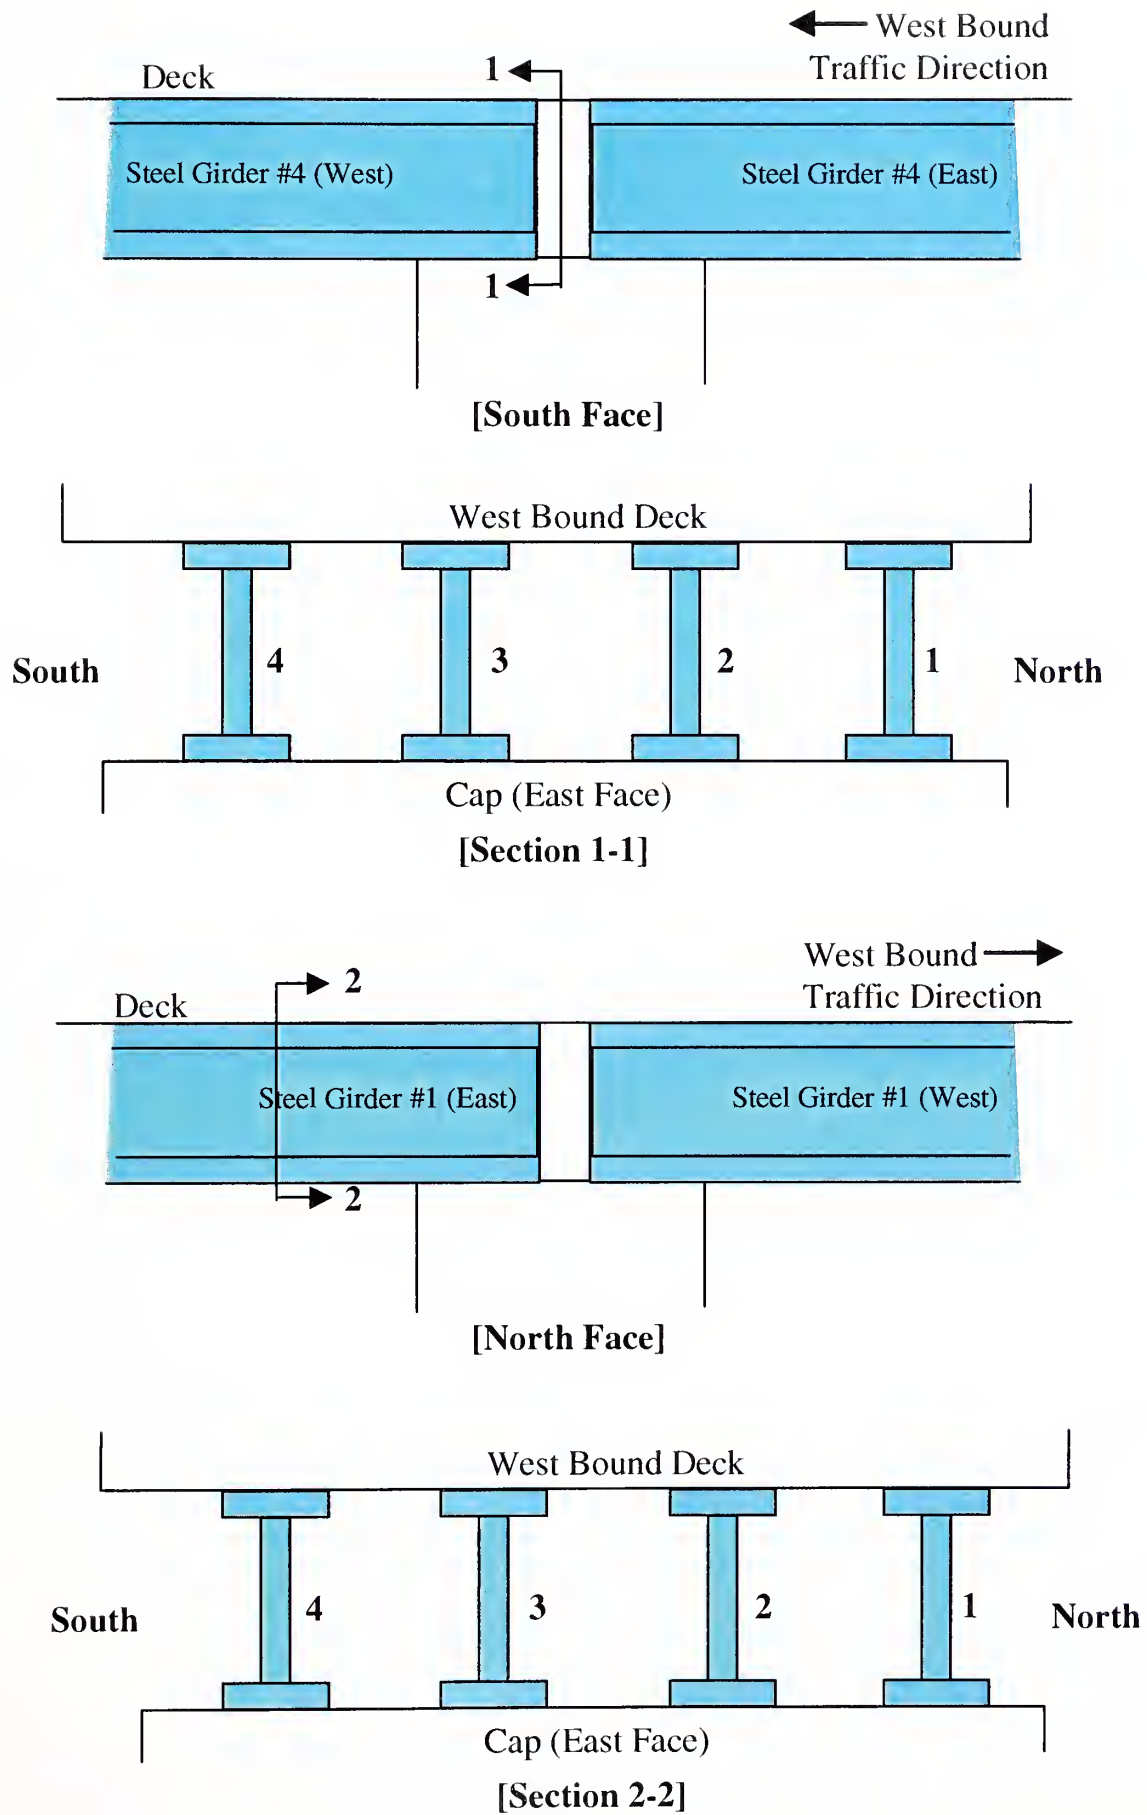
**Figure 41B. Condition of Girder Joints over Bent No. 11 (West Bound).**

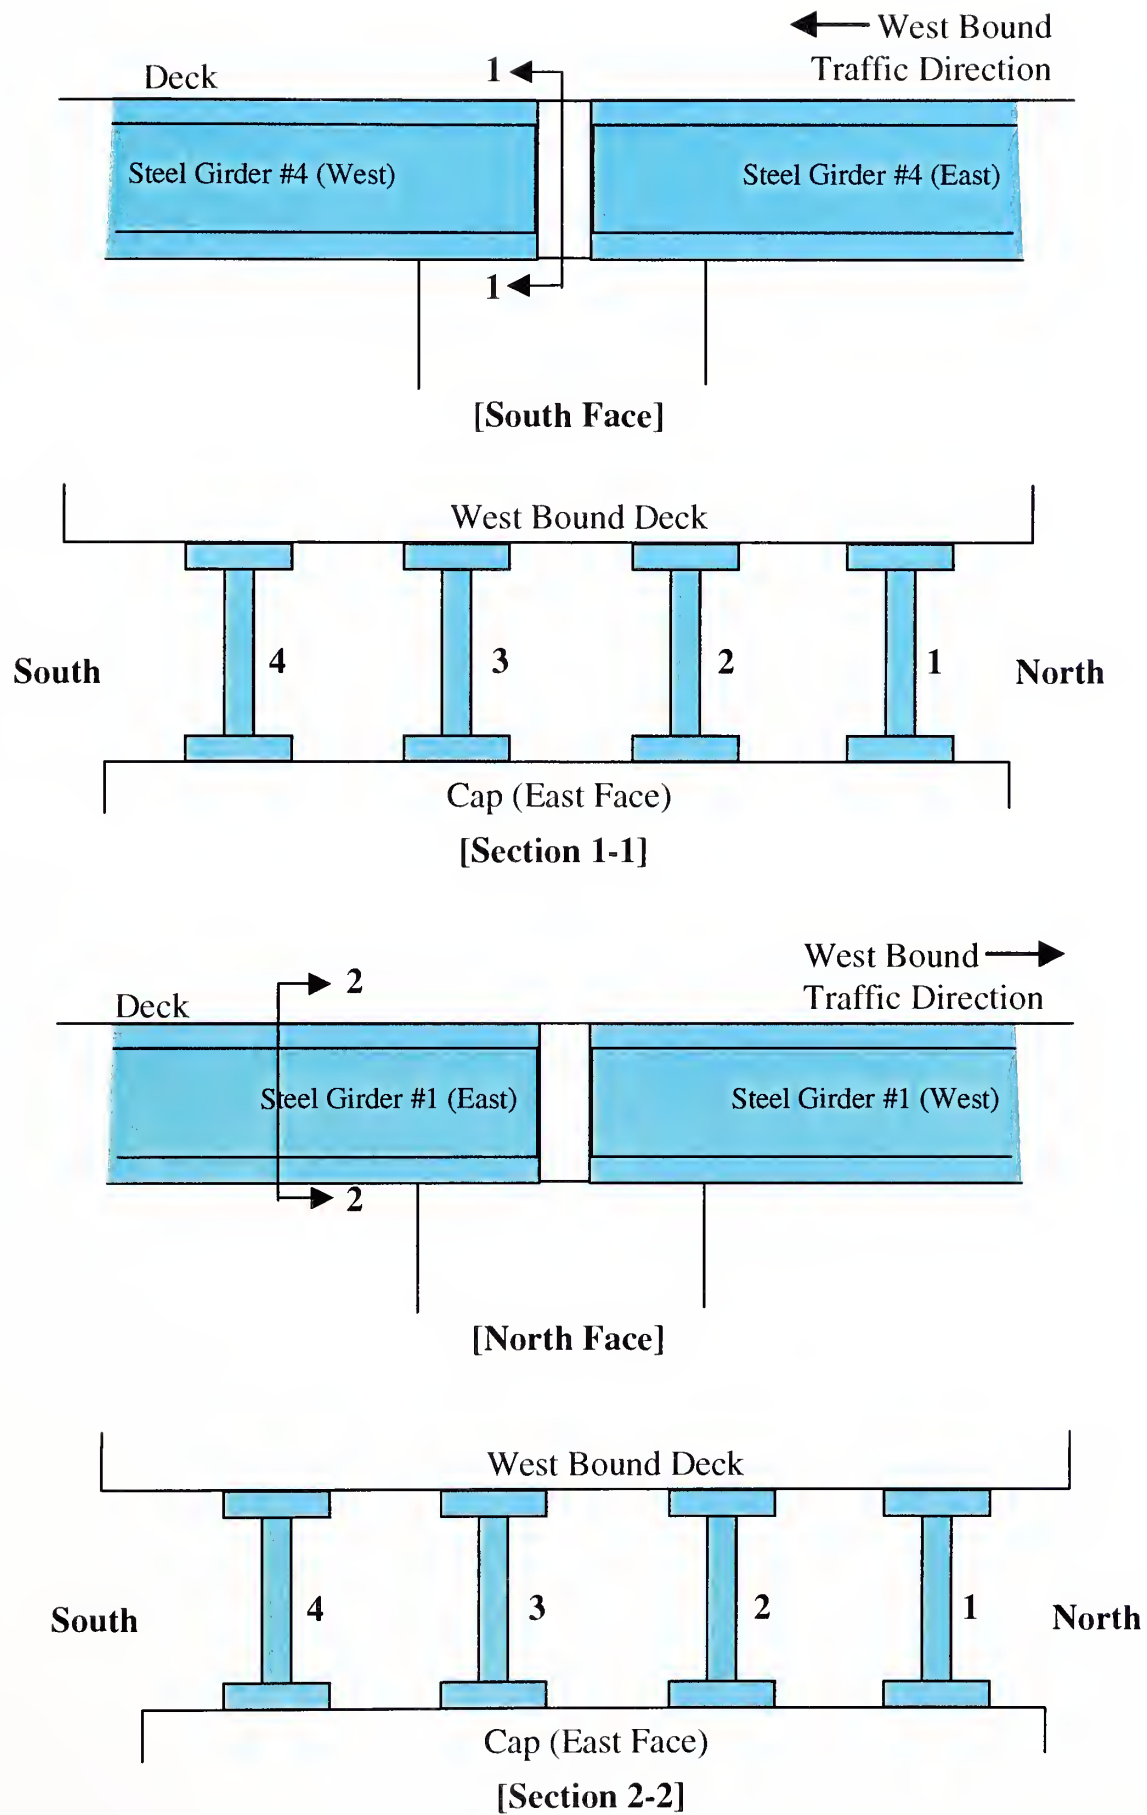
**Figure 42B. Condition of Girder Joints over Bent No. 12 (West Bound).**

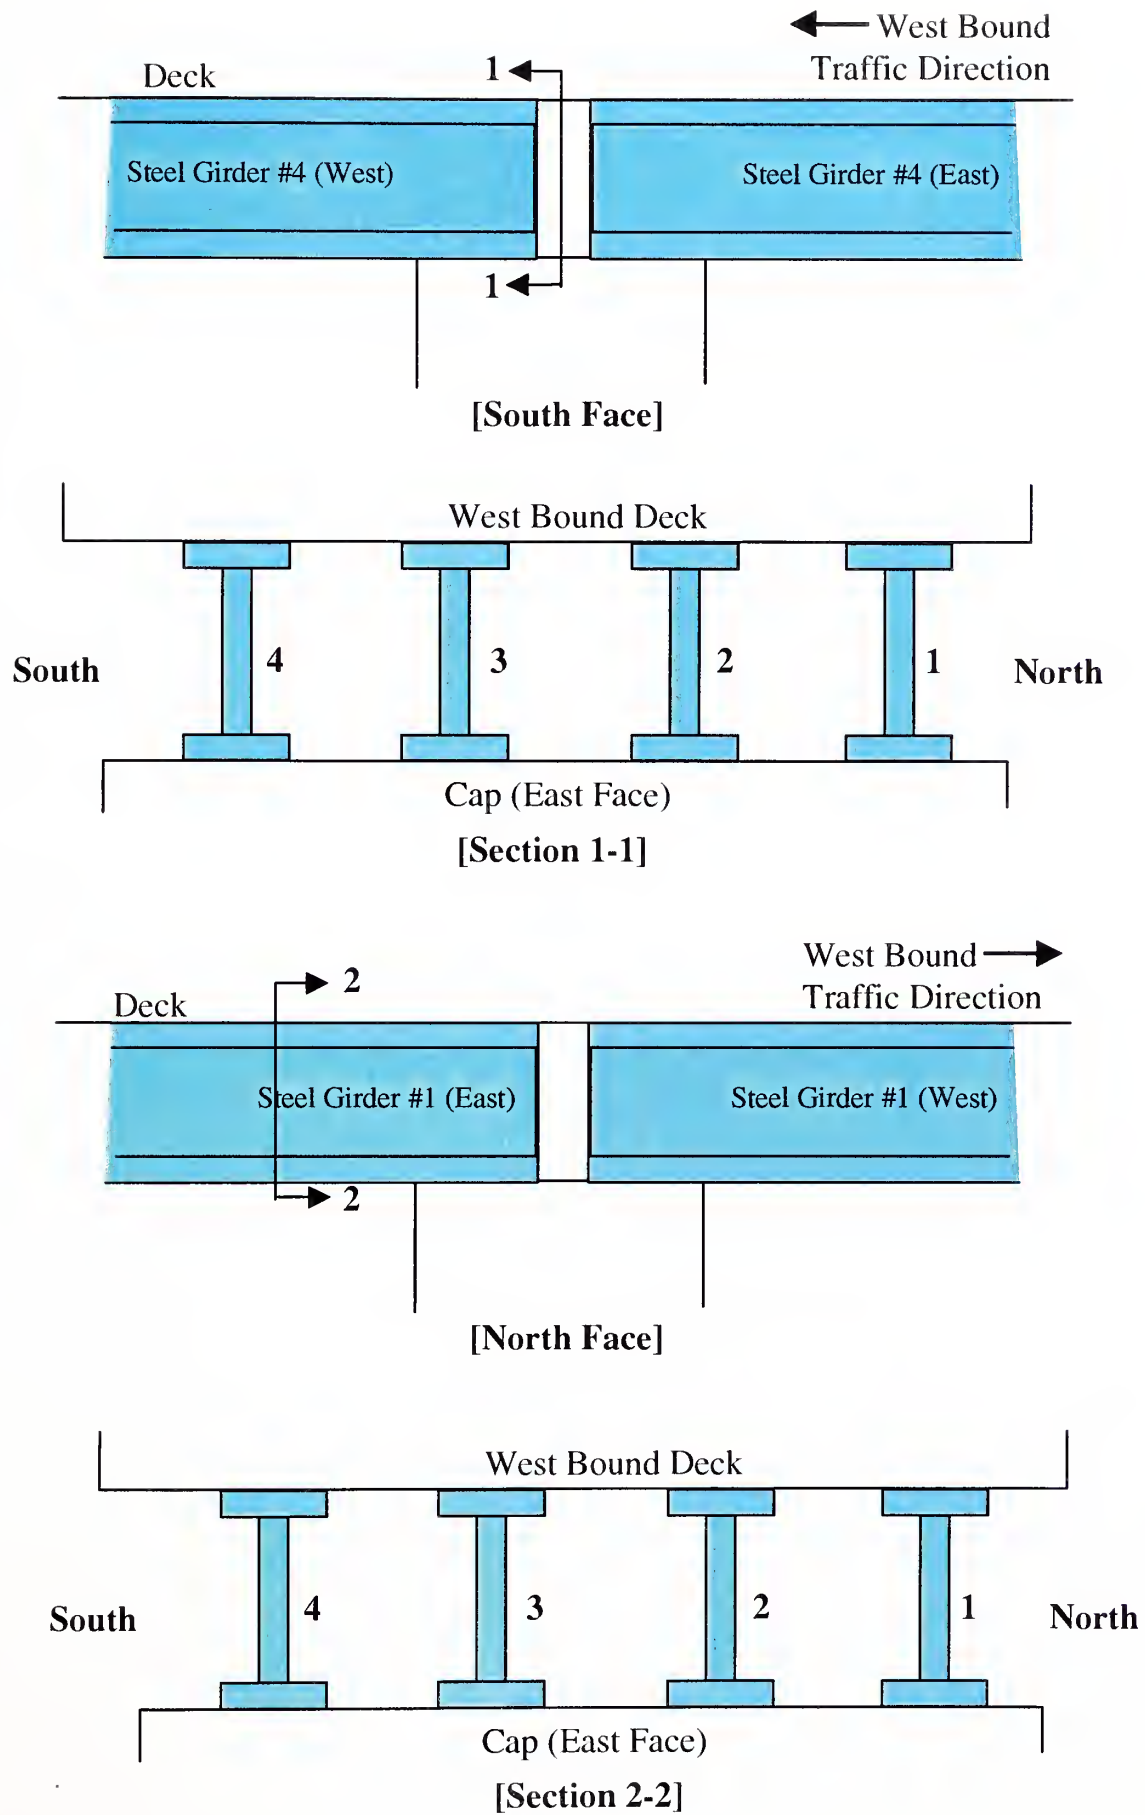
Figure 43B. Condition of Girder Joints over Bent No. 13 (West Bound).

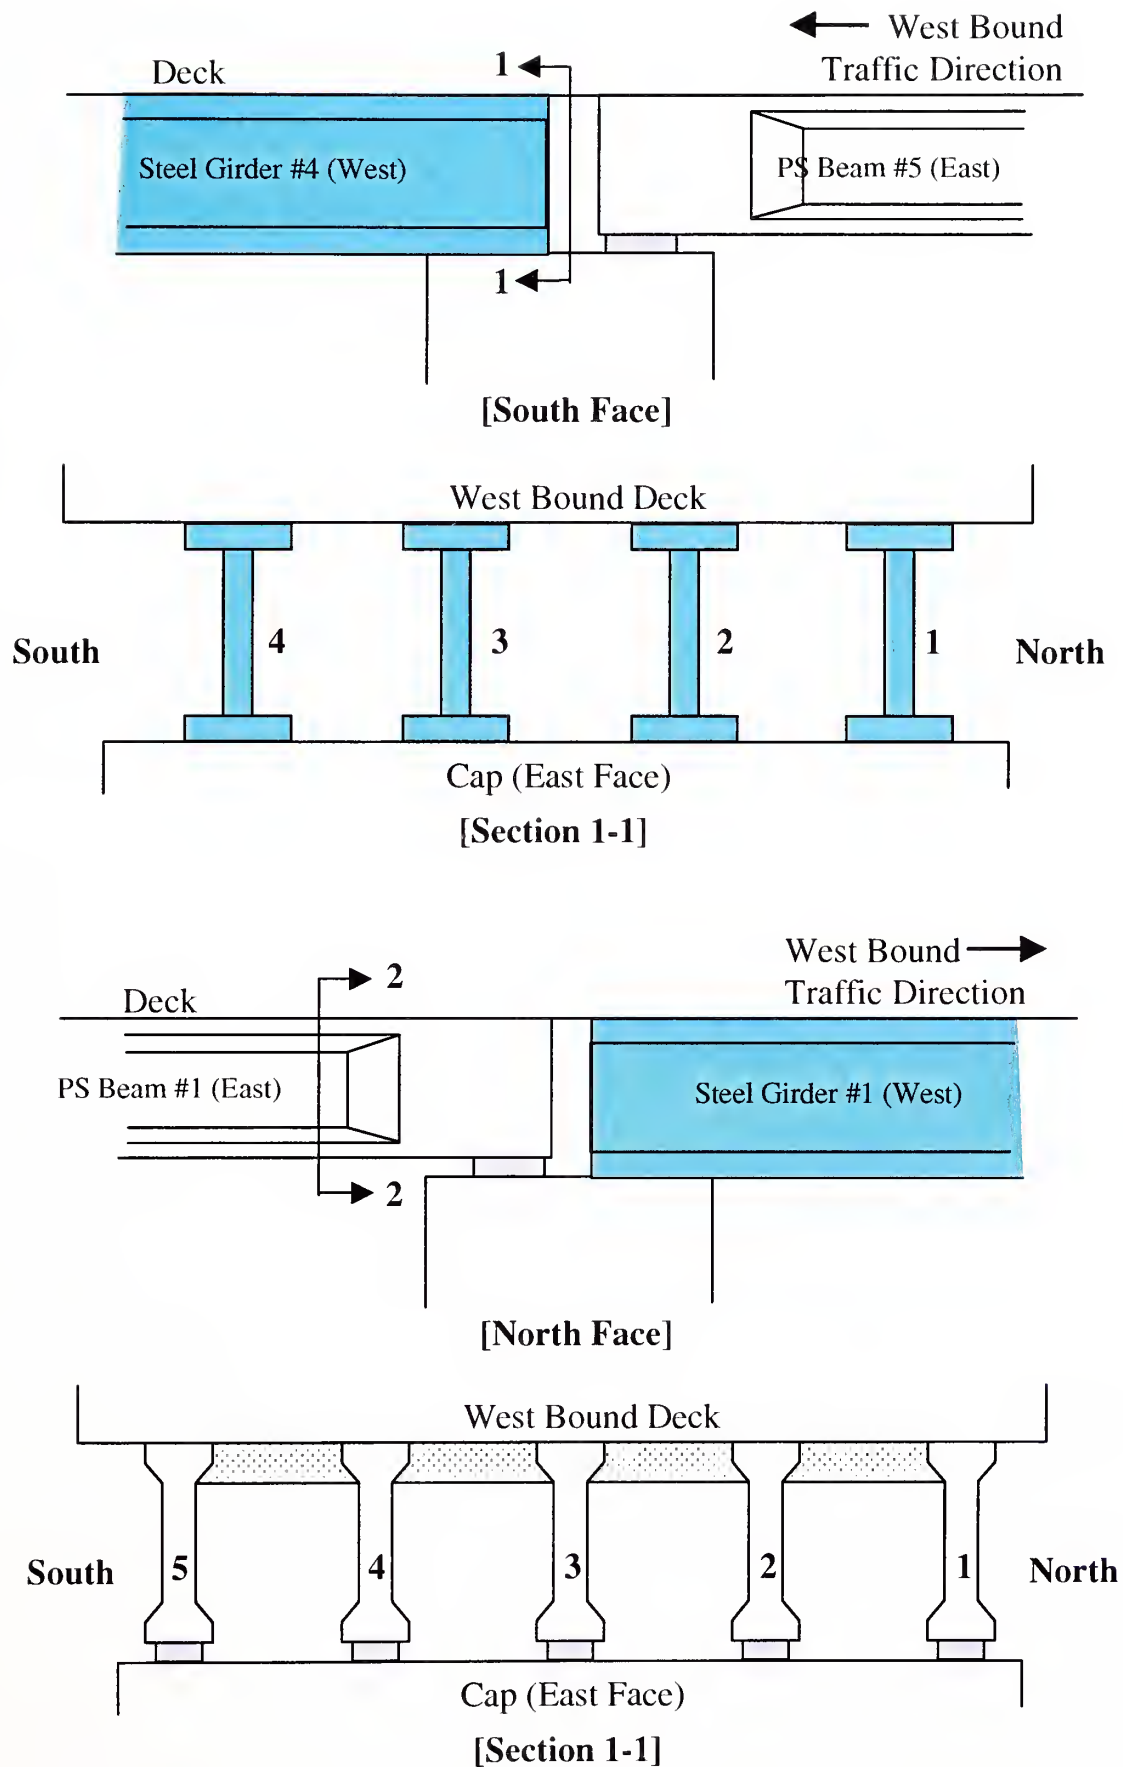
**Figure 44B. Condition of Beam Joints over Bent No. 14 (West Bound).**

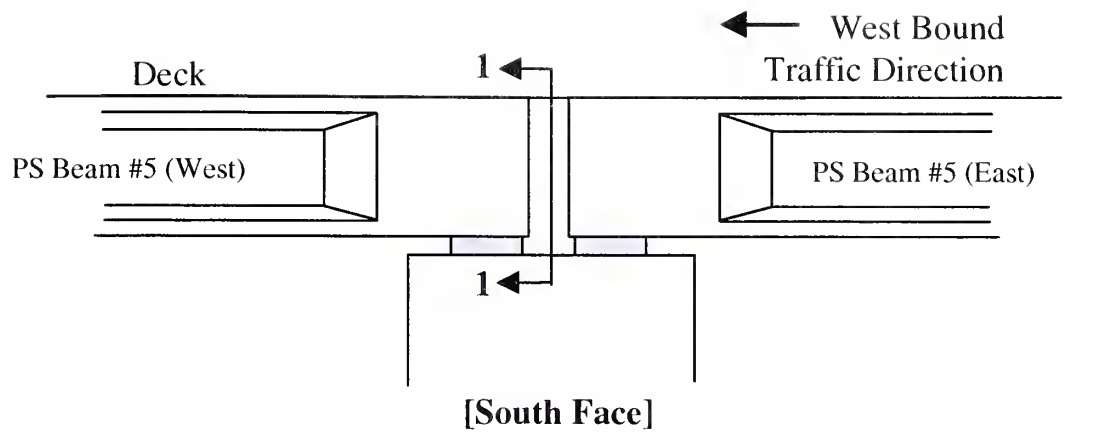
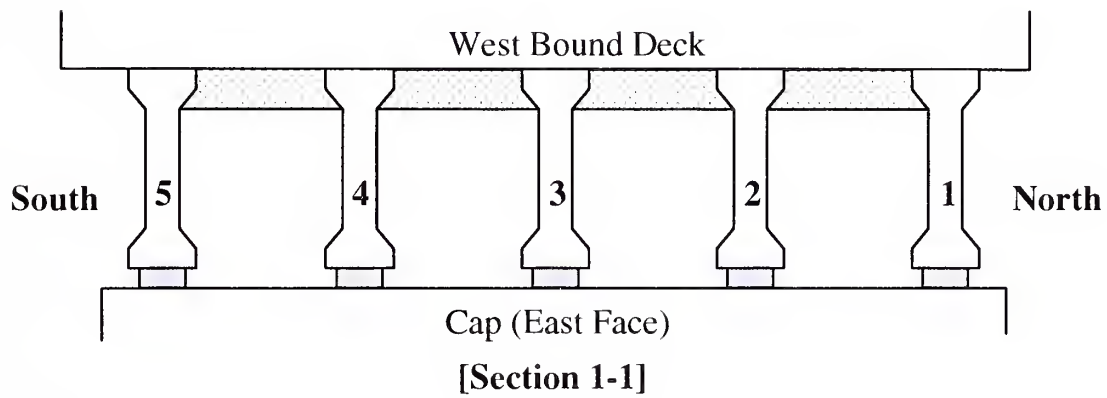
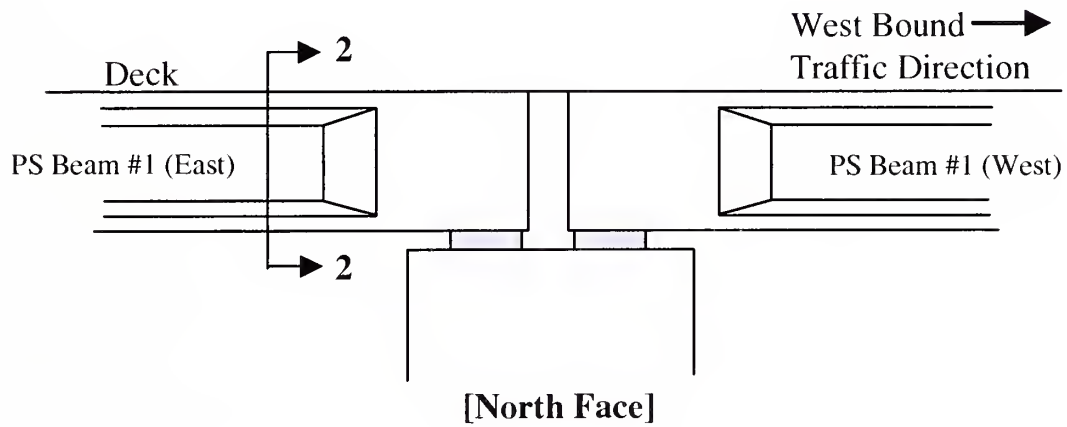
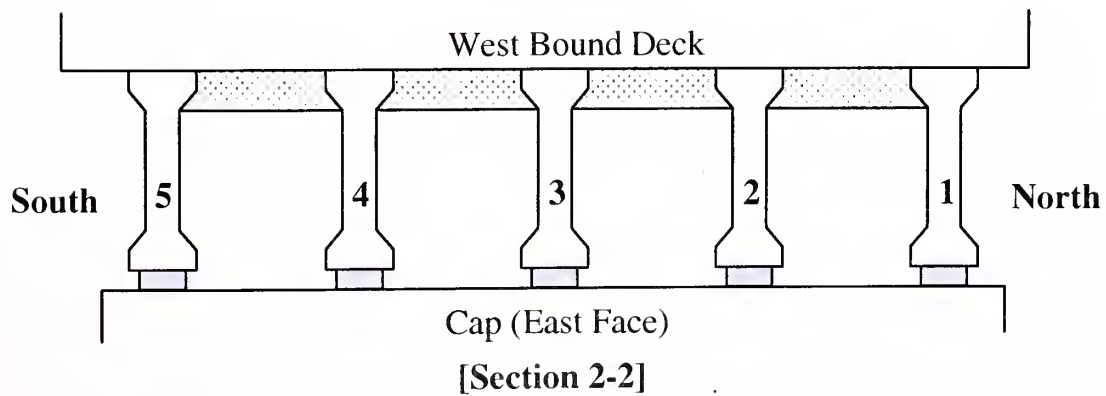
Figure 45B. Condition of Beam Joints over Bent No. 15 (West Bound).

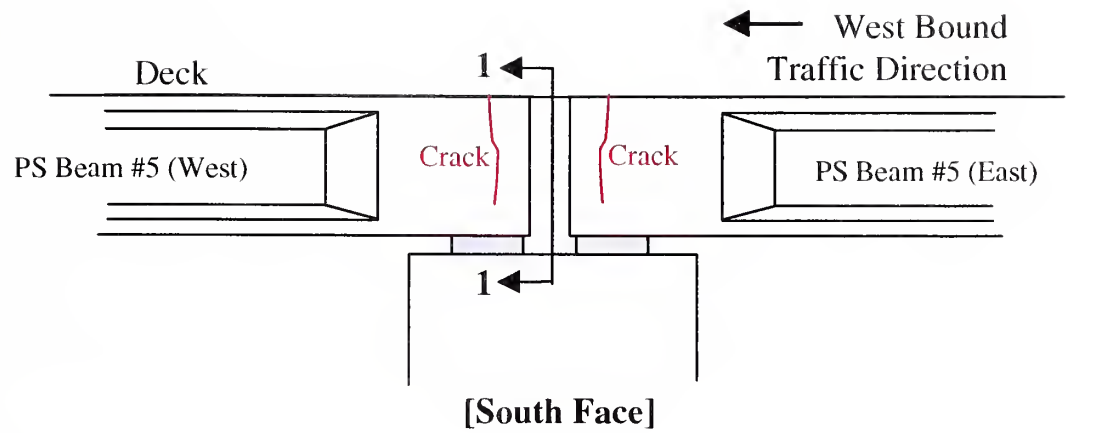
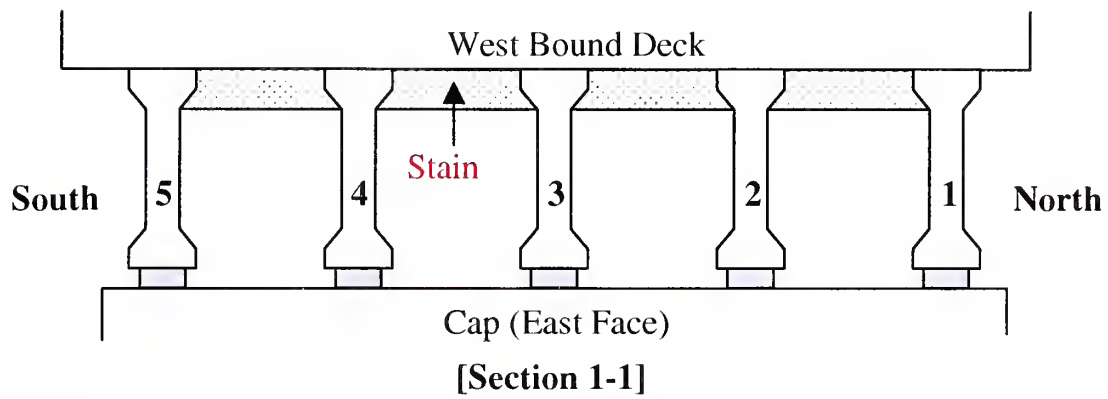
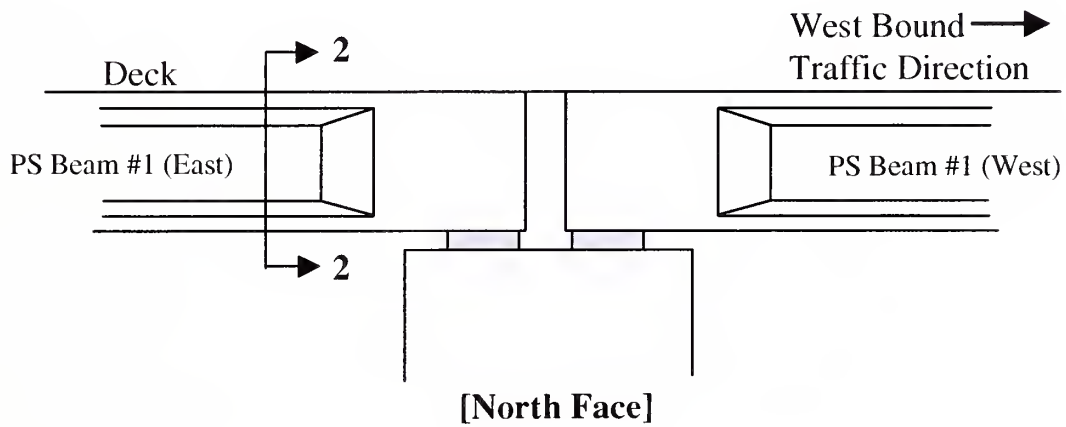
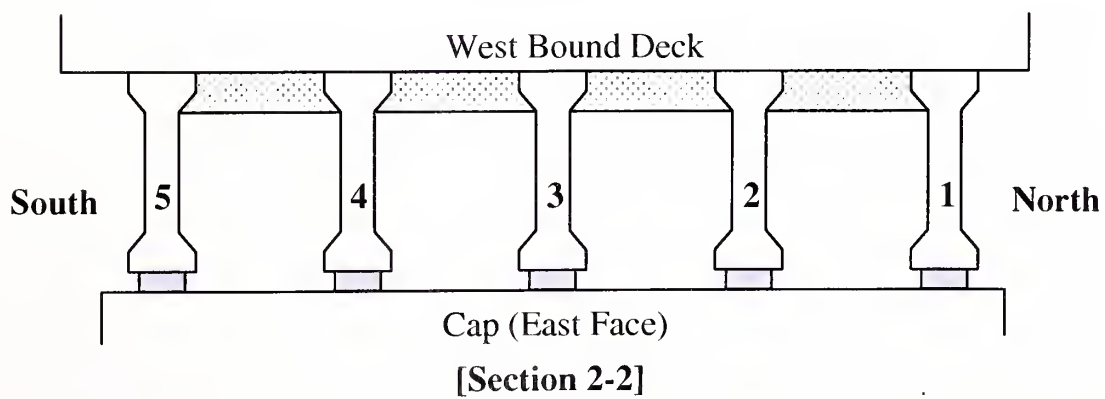
**Figure 46B. Condition of Beam Joints over Bent No. 16 (West Bound).**

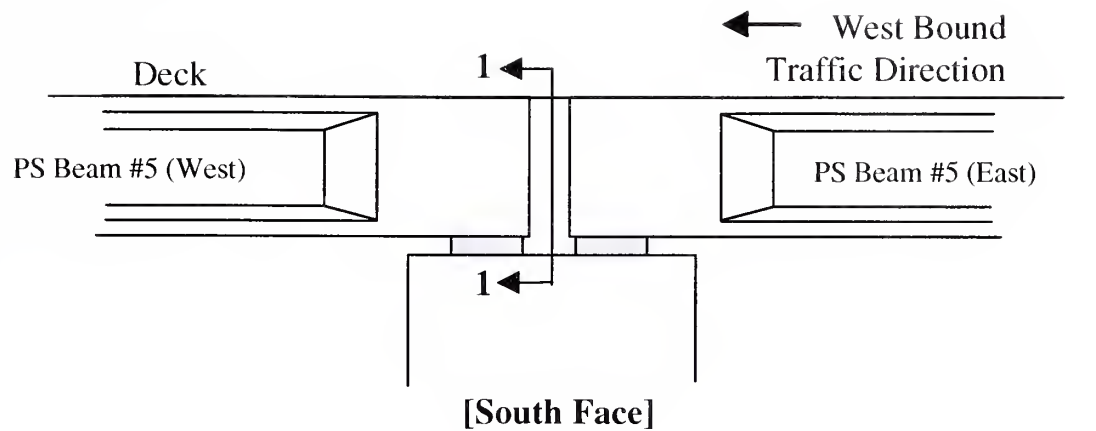
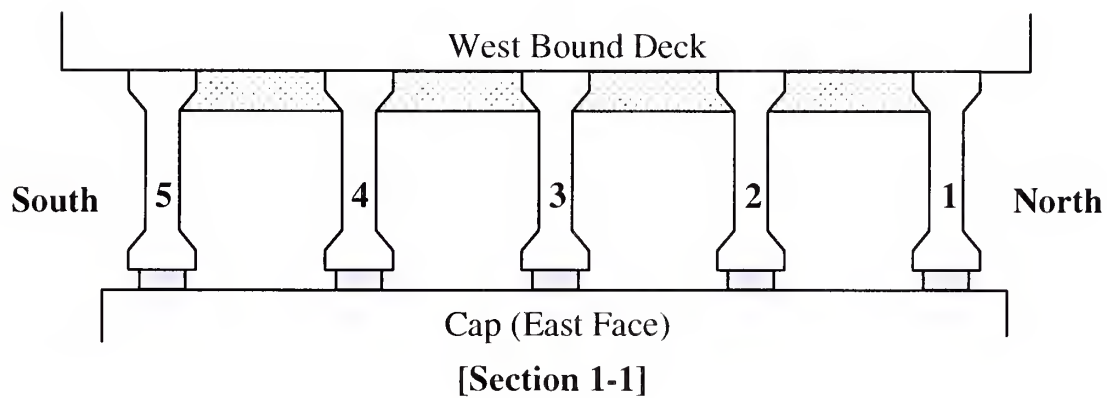
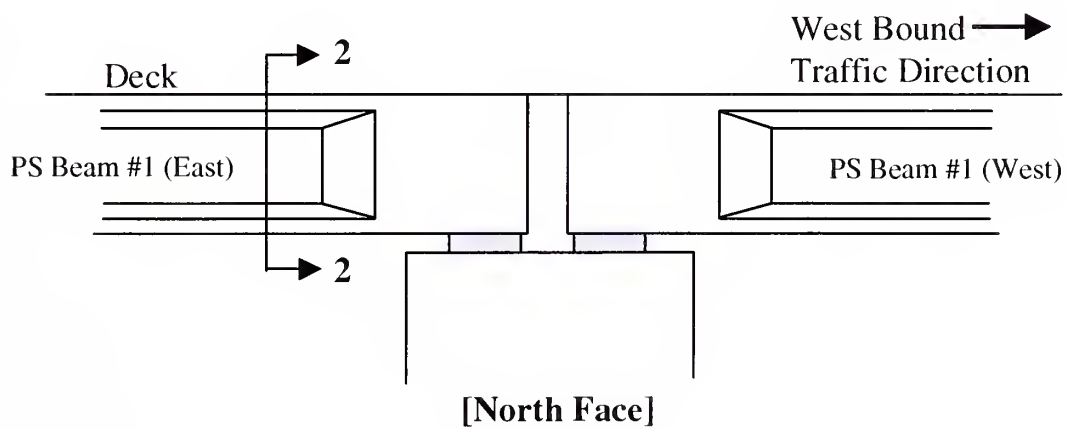
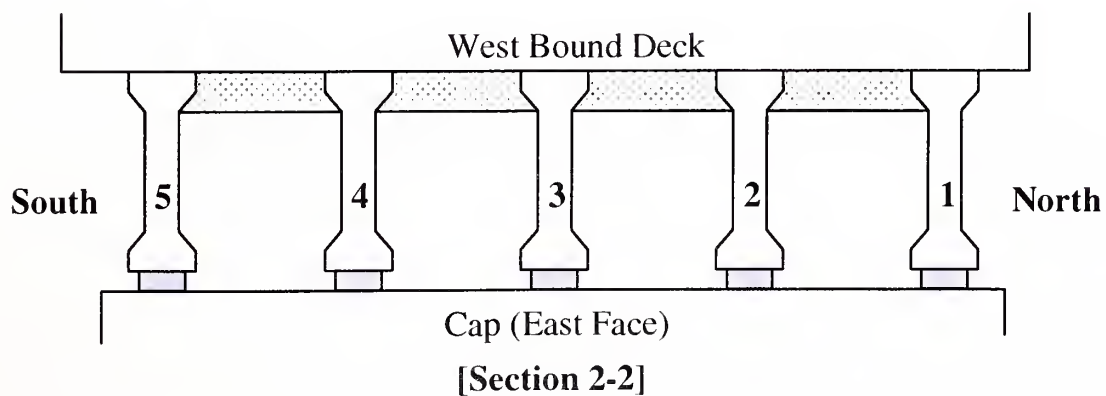
Figure 47B. Condition of Beam Joints over Bent No. 17 (West Bound).

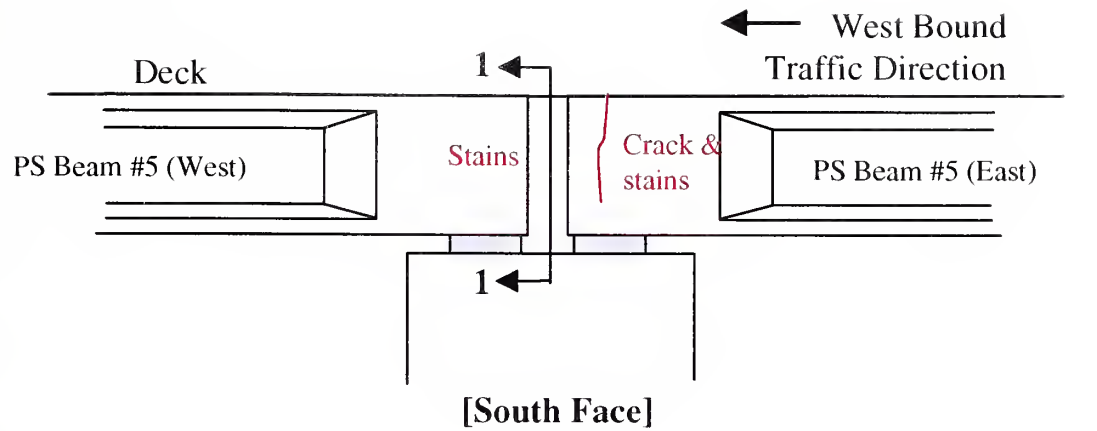
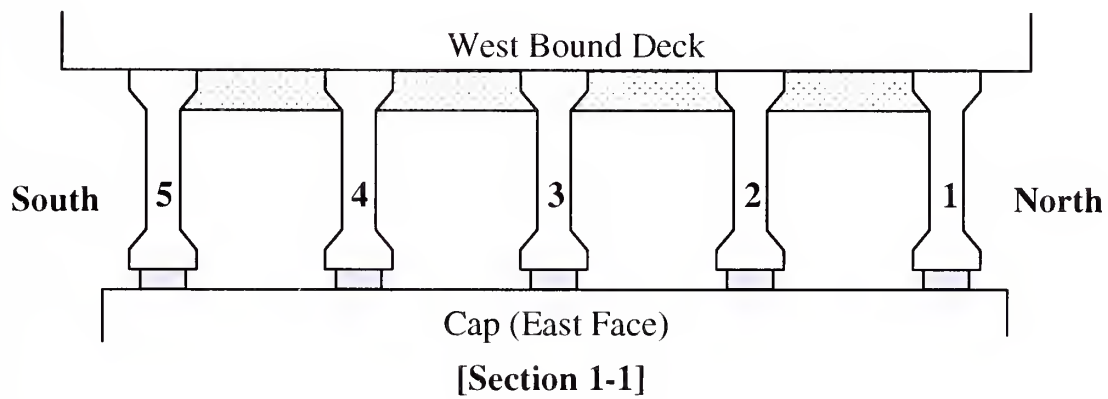
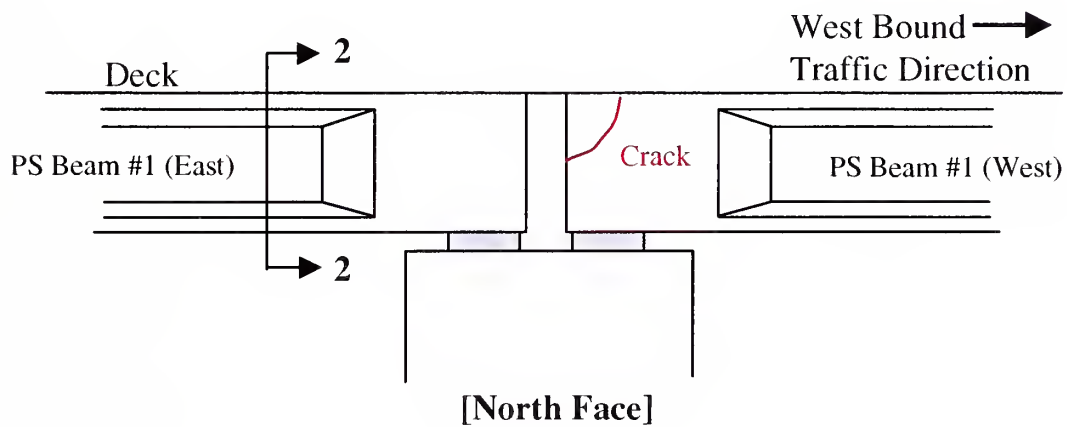
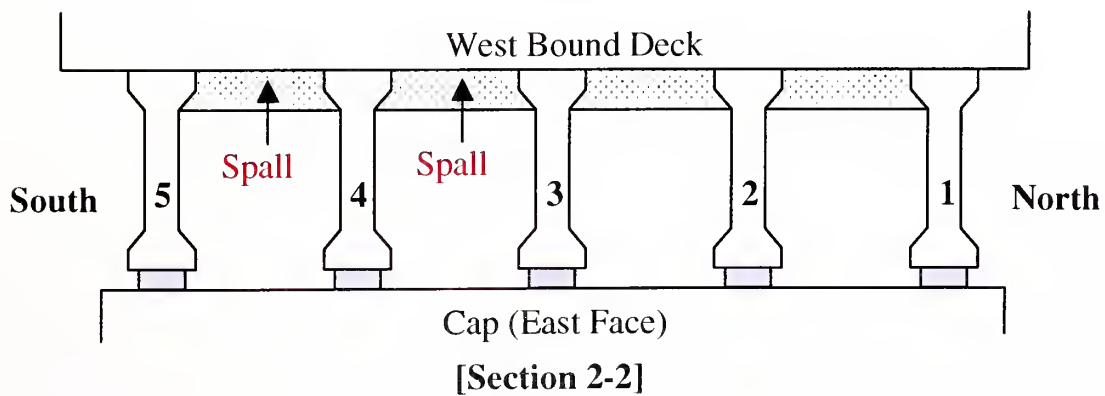
**Figure 48B. Condition of Beam Joints over Bent No. 18 (West Bound).**
